TASK 5: DATA ANALYSIS AND REPORTING

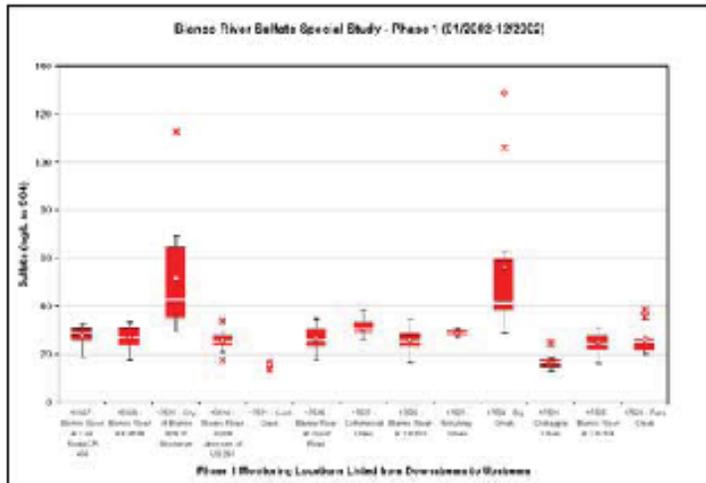
Figure 1. Box and whisker plot of sulfate concentrations at the 13 locations monitored during the first phase of the special sulfate study on the Upper Blanco River.

Between September of 1999 and November of 2000 eight of the thirteen sulfate samples collected at the GBRA routine monitoring station, on the Blanco River at FM165 (Station #12668), returned values greater than the stream standard of 50 milligrams per liter (mg/L). GBRA initiated a special study in the upper portions of this segment, in order to identify the reason for the high sulfate values. During the first phase of the study, 13 monitoring locations were sampled for sulfate and conductivity concentrations from January to December of 2002. The phase one study locations included a site on the Blanco River at Cox Road, which was 4.9 miles downstream of the GBRA routine monitoring station at FM165. Phase one of the special study also monitored 11 additional stations, up to 10.8 miles upstream of the GBRA monitoring station at FM165. The phase one study stations upstream of the GBRA monitoring site included 4 main stem sites and 6 tributaries, as well as the City of Blanco wastewater discharge, which was located 2 miles upstream of the GBRA FM 165 station. The first phase of the sulfate study revealed that only the samples from the Big Creek tributary and the city of Blanco WWTP discharge contained sulfate concentrations exceeding the stream standard, as seen in Figure 1. The city of Blanco WWTP discharge was eliminated as a cause for high sulfate concentrations because it was utilizing its permitted discharge water for crop irrigation during the study sampling dates, as well as during the initial period of high sulfate concentrations in 1999 and 2000. The second phase of the study investigated 4 sites on the Big Creek tributary, a well in the Big Creek drainage basin, and a station on the Blanco River 2 miles downstream of the Big Creek confluence, as seen in Figure 2. The analysis of the data from this study showed that the groundwater in this portion of the river basin significantly contributed to high sulfate concentrations, especially during times of low flow.

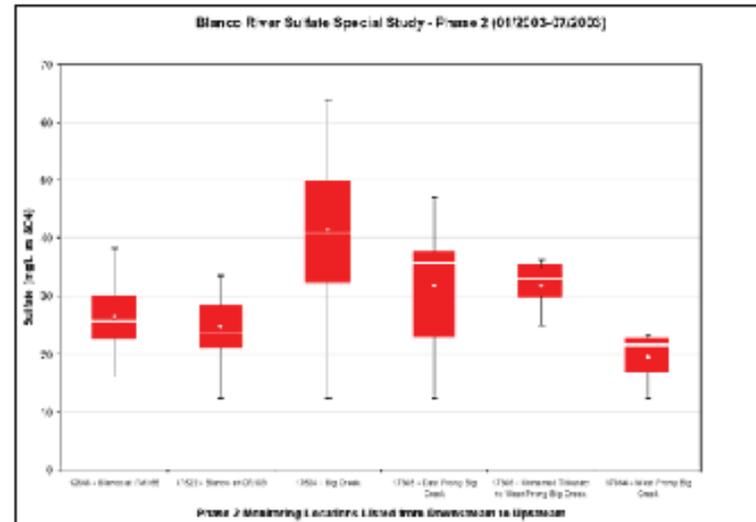
Figure 2. Box and whisker plot of sulfate concentrations at the 6 locations monitored during the second phase of the special sulfate study on the Blanco River.

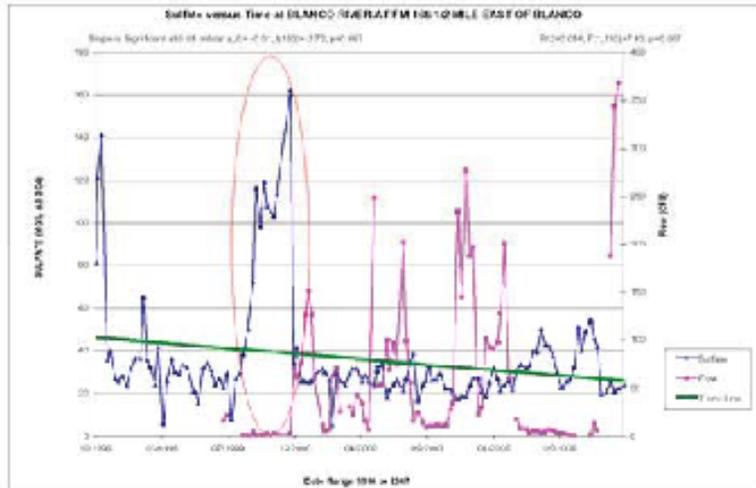
Figure 3. Sulfate concentration versus time at the Blanco River at FM 165 (12668) GBRA monitoring station (period of time that prompted sulfate special study is divided in red).

Over the period of record, the **sulfate** concentration at the Blanco at FM 165 site (#12668) had a median value of 28.8 mg/L with a maximum value of 162 mg/L and a minimum value of 5.0 mg/L. The sulfate levels at this site exceeded the stream screening criteria of 50 mg/L 14 times over the period of record, as seen in Figure 3. The sulfate concentration at this site appears to be exhibiting a significant downward trend with time at the 0.05 critical α , $\beta = -0.01$, $t(130) = -2.72$, $p = 0.007$. A significant portion of the variance in sulfate levels at this site appears to be explained by stream flow, $R^2 = 0.114$, $F(1,85) = 10.89$, $p = 0.001$, and over the period of record there appears to be an inverse relationship between sulfate concentration and flow at the 0.05 critical α , as a rise in flow results in a decrease in sulfate, $\beta = -0.11$, $t(85) = -3.30$, $p = 0.001$, as seen in Figure 4. Nitrate nitrogen, ammonia nitrogen, total phosphorus, and chlorophyll a were also analyzed at this monitoring location. **Nitrate Nitrogen** was reported under three different STORET codes at this location. Combining the results of all three STORET codes, the median nitrate concentration was 0.27 mg/L, with a maximum value of 1.78 mg/L and a minimum value of <0.01 mg/L. None of the samples exceeded the nitrate nitrogen screening criteria of 1.95 mg/L. The median **ammonia nitrogen** concentration of the GBRA monitoring location at FM 165 was 0.04 mg/L, with a maximum value of 0.34 mg/L and a minimum value of <0.02 mg/L. This station exceeded the ammonia screening concentration of 0.33 mg/L one time, in April of 2000, during a prolonged period of low stream flow. The median **total phosphorus** concentration was below the limit of quantification for the method and when total phosphorus was detected in a sample it did not exceed the screening concentration of 0.69 mg/L. The

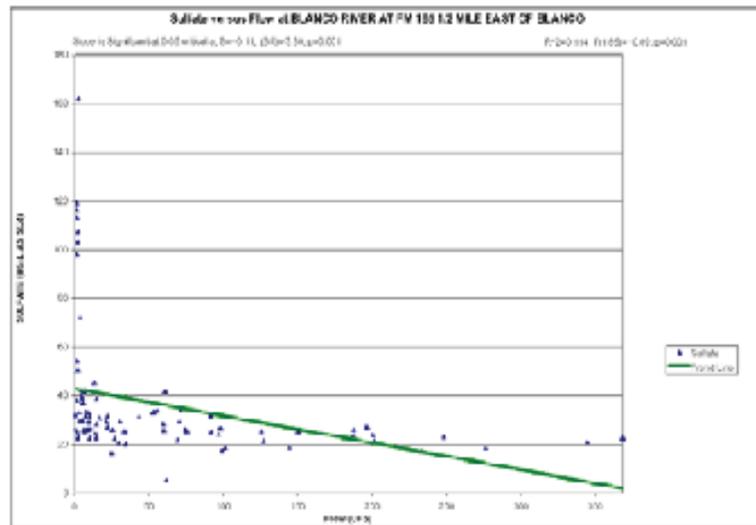
Figure 4. Sulfate concentration versus Flow at the Blanco River at FM 165 (12668) GBRA Monitoring Station. An inverse relationship was found to exist between sulfate and flow.

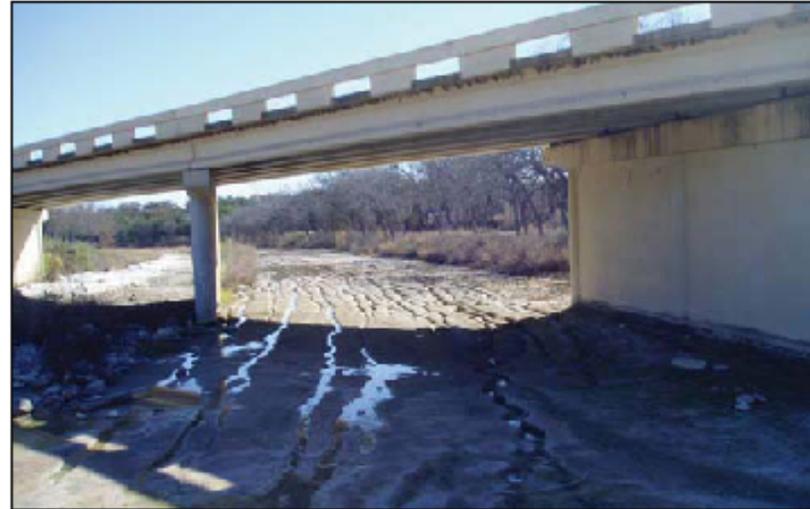
The Blanco River at FM 165 (site no. 12668) during the drought of 2006.

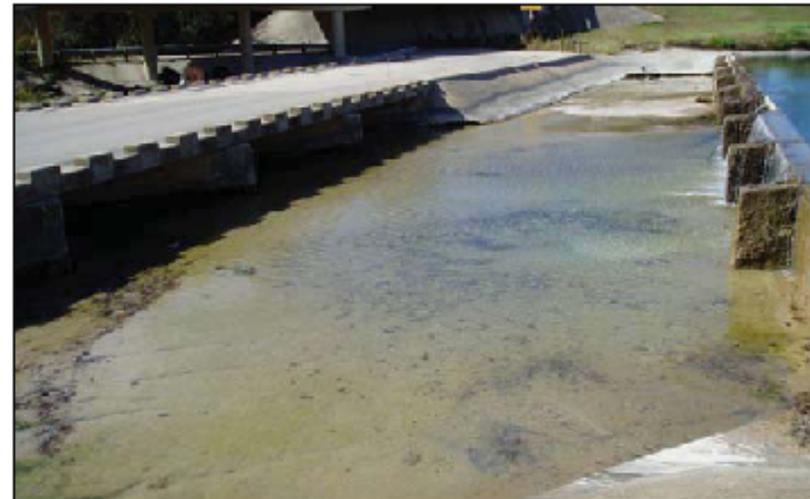
Blanco River at FM 165 (site no. 12668) during normal to low flow.

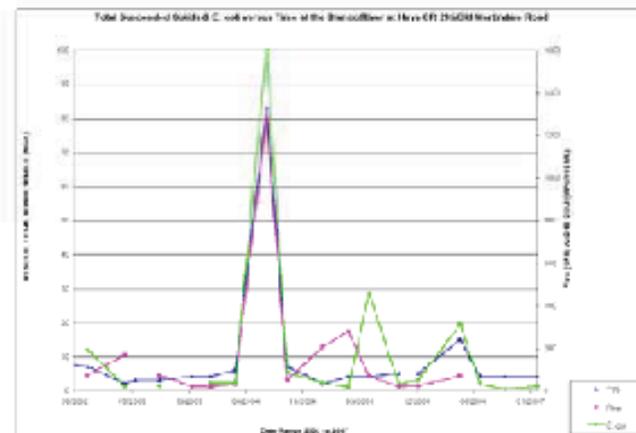
Figure 1 - Total suspended solids and *E. coli* over time at the TCEQ Blanco River at CR 295 (12631) monitoring location.

The lower Blanco River has no major tributaries to contribute to flow and sediment loading of the stream. High flow events are almost exclusively associated with flow contributions from segment 1813 or runoff from dry creeks within the segment. The median instantaneous flow of the CR 295 monitoring station, in segment 1809, was 66 cubic feet per second (cfs). However, the stream experienced wide swings in flow, from 18 cfs to 1270 cfs, throughout the period of record. Due to the bedrock substrate of the lower Blanco, total suspended solid (TSS) values are relatively low in this segment of the river. The median TSS value for the CR 295 station is 4.0 milligrams per liter (mg/L), with a maximum value of 83 mg/L during a high flow event. Sediment loading during high flows is often indicative of bacteria in the water column (figure 1) because storm water brings in bacteria and the high flows keep solids suspended in the water, which keep ultraviolet light from the sun from penetrating the water and killing the bacteria. The stream standard for contact recreation is a geometric mean of 126 organisms per 100 milliliters, and a single sample concentration of 394 organisms per 100 milliliters. The CR 295 monitoring location has a geometric mean *E. coli* concentration of 50 organisms per 100 ml (MPN/100 mL). This site exceeded

the stream contact recreation grab standard for *E. coli* two times throughout the period of record. Both events occurred during periods of high flows and the highest recorded *E. coli* number at this site, 1,600 MPN/100ml, was recorded at the same time as the highest recorded total suspended solid concentration.

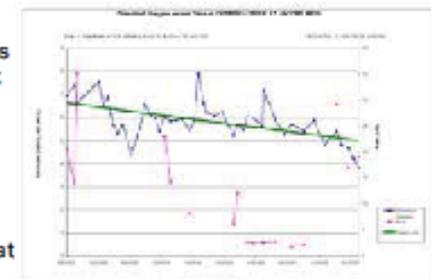
Figure 1. Dissolved oxygen over time at Jacob's Well (12677) on the Cypress Creek.

The 2008 draft Texas Water Quality Inventory lists Cypress Creek with a concern for depressed dissolved oxygen. Out of 161 measurements, 35 fell below the screening criteria of 6.0 milligrams per liter (mg/L). The station located at Jacob's Well which is the headwaters of the creek has a median dissolved oxygen concentration of 5.9 mg/L, ranging from 3.8 to 7.9 mg/L. The water leaving the well, as expected for ground water, is low in dissolved oxygen, but over the period of time that data has been collected at the well we see a degrading trend in dissolved oxygen (figure 1).

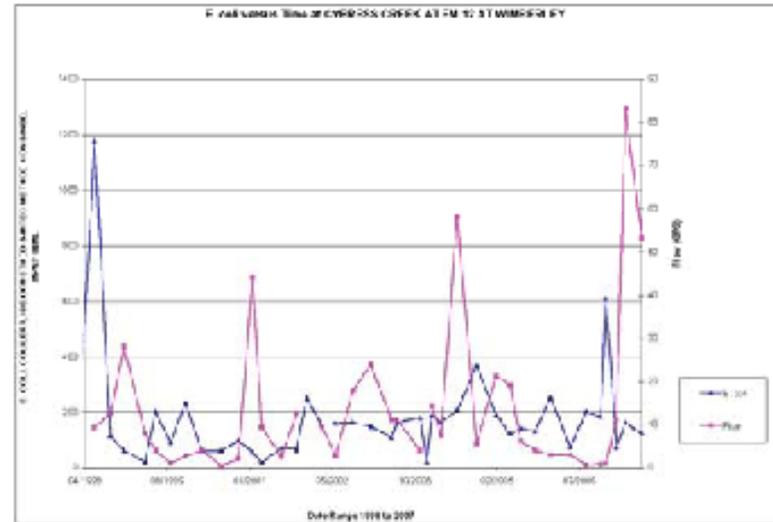
Figure 2. *E. coli* concentrations and flow over time at the Cypress Creek at FM 12 site (12674).

periods where the inverse appears to be true (Figure 2). A possible explanation for this phenomenon could be that the contributions of *E. coli* from failing septic tanks in the city are more easily detected when the baseflow is not sufficient enough to dilute the bacteria.

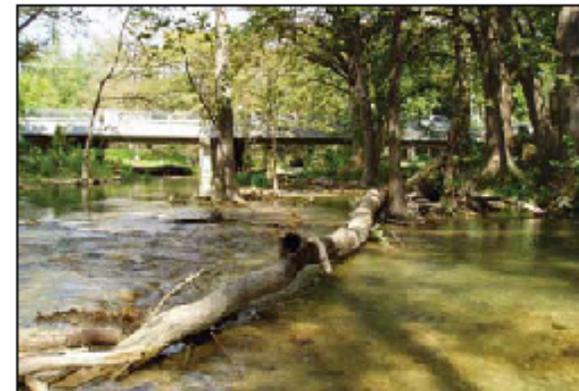
Cypress Creek at RR 12 in Wimberley (site no. 12674).

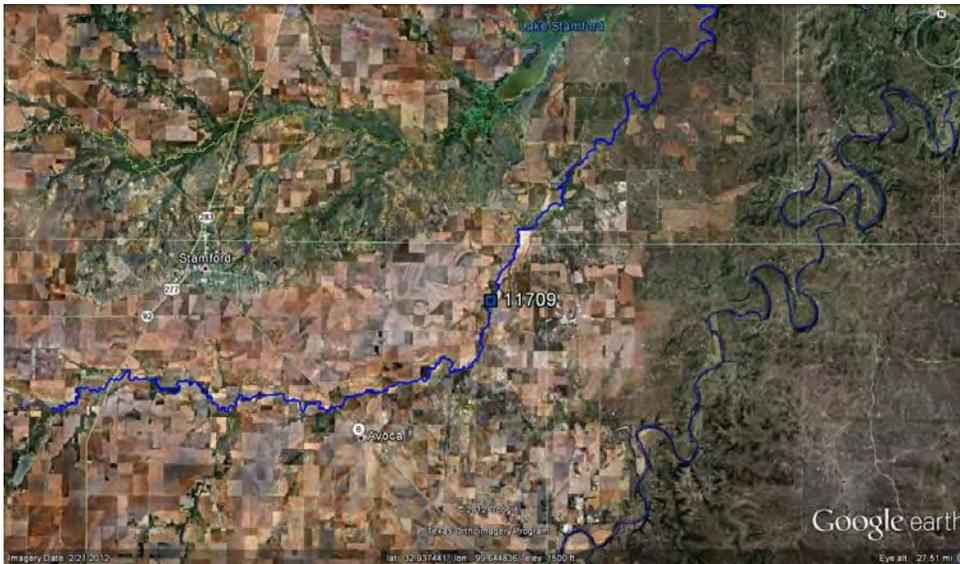
Figure 3.3.2.3 Data collected at Station 11709 - CALIFORNIA CREEK AT FM 142 EAST OF STAMFORD is used to assess Segment 1232A_01.

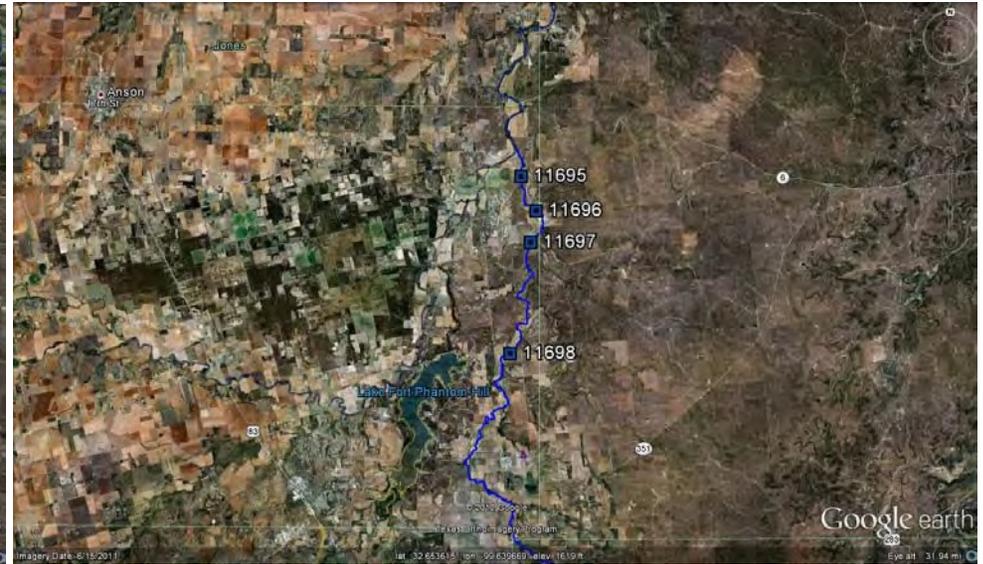
Figure 3.3.2.4 Data collected at these four stations is used to assess Segment 1232B_01.
